RATING SYSTEM FOR EVALUATING THE ACOUSTICAL ENVIRONMENT OF EXISTING SCHOOL FACILITIES

David P. Walsh

Wilson, Ihrig & Associates, Inc.
~~2344 Sixth Street~~
~~Berkeley, California 94710~~
5605 OCEAN VIEW DRIVE
OAKLAND, CALIFORNIA 94618

Presented at the 82nd Meeting of the Acoustical Society of America;
Session HH, Room Acoustics; Denver, Colorado; 22 October 1971

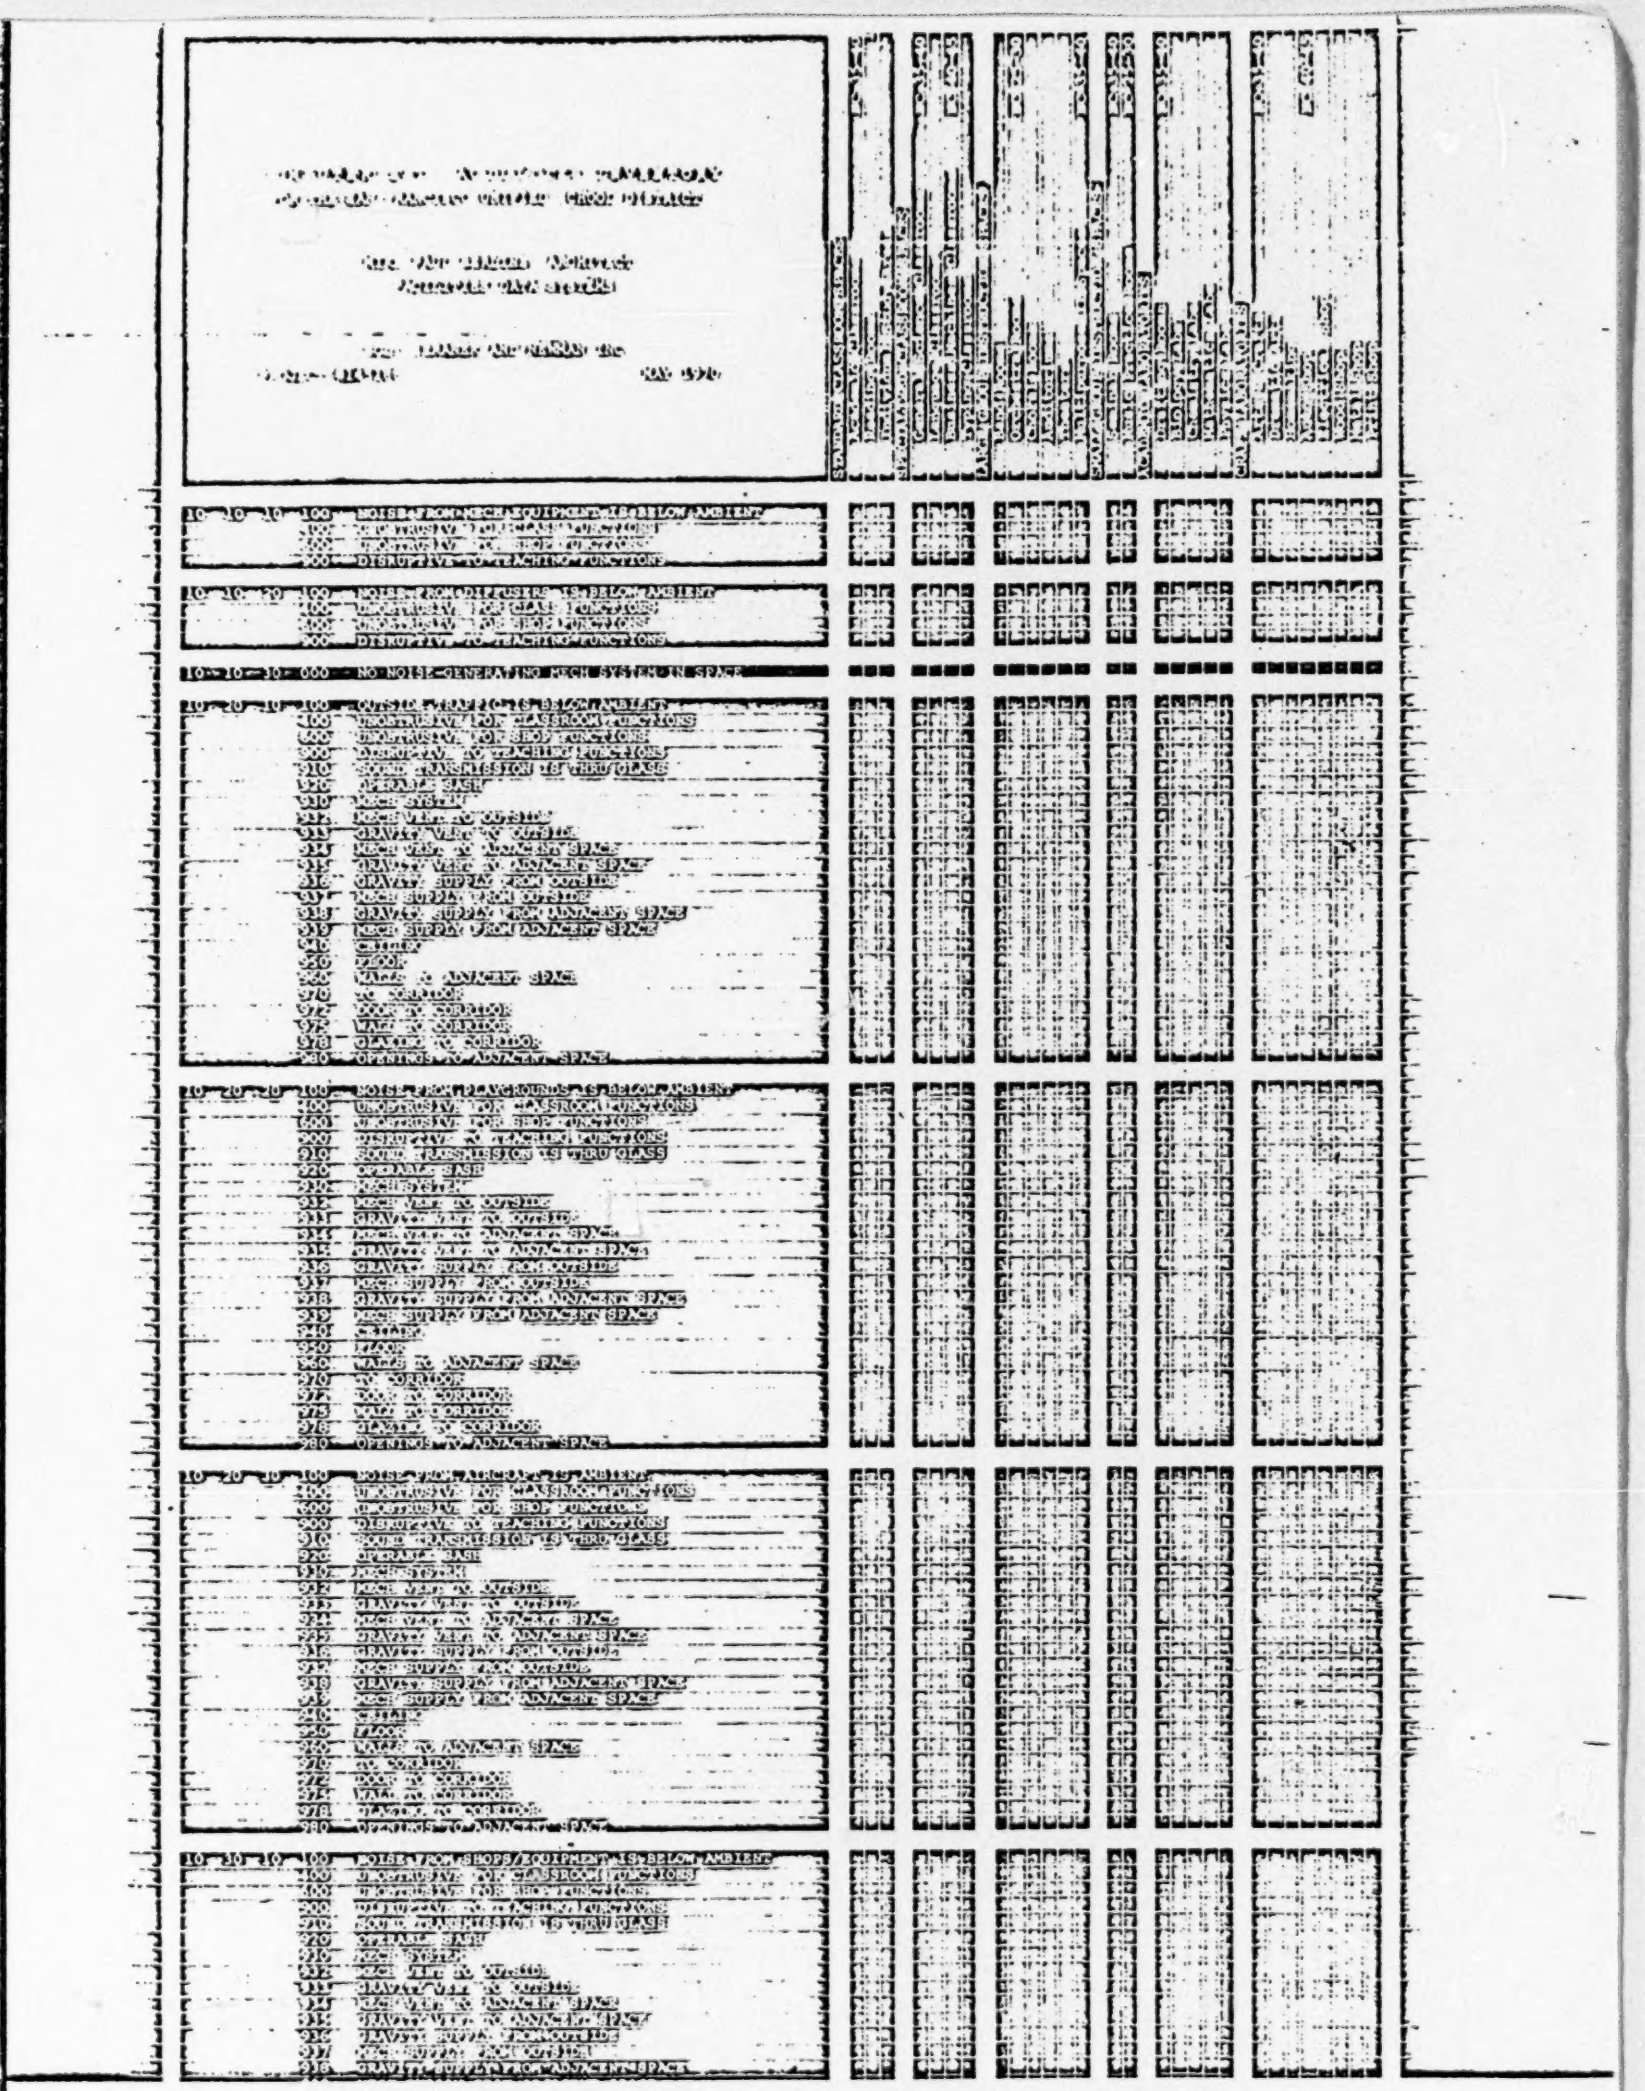
FIGURE 6: PORTION OF PRELIMINARY ACOUSTICAL SURVEY FORM

The next step was to prepare a Survey Form which we could take to the various schools and record data on sub-standard acoustical areas. This required taking the FIELD APPROXIMATIONS of our standard acoustical units of measure to identify the typical noise sources encountered in schools and relating them to the normal sound transmission paths found in school construction. An example of this is shown on Figure 5 for the major noise source in schools - playgrounds. We then combined these parameters with the SPACE IDENTIFICATION TYPES to allow for every possible combination of noise source, sound transmission path, and teaching space. This combination of parameters resulted in a Survey Form which is shown on Figure 6.

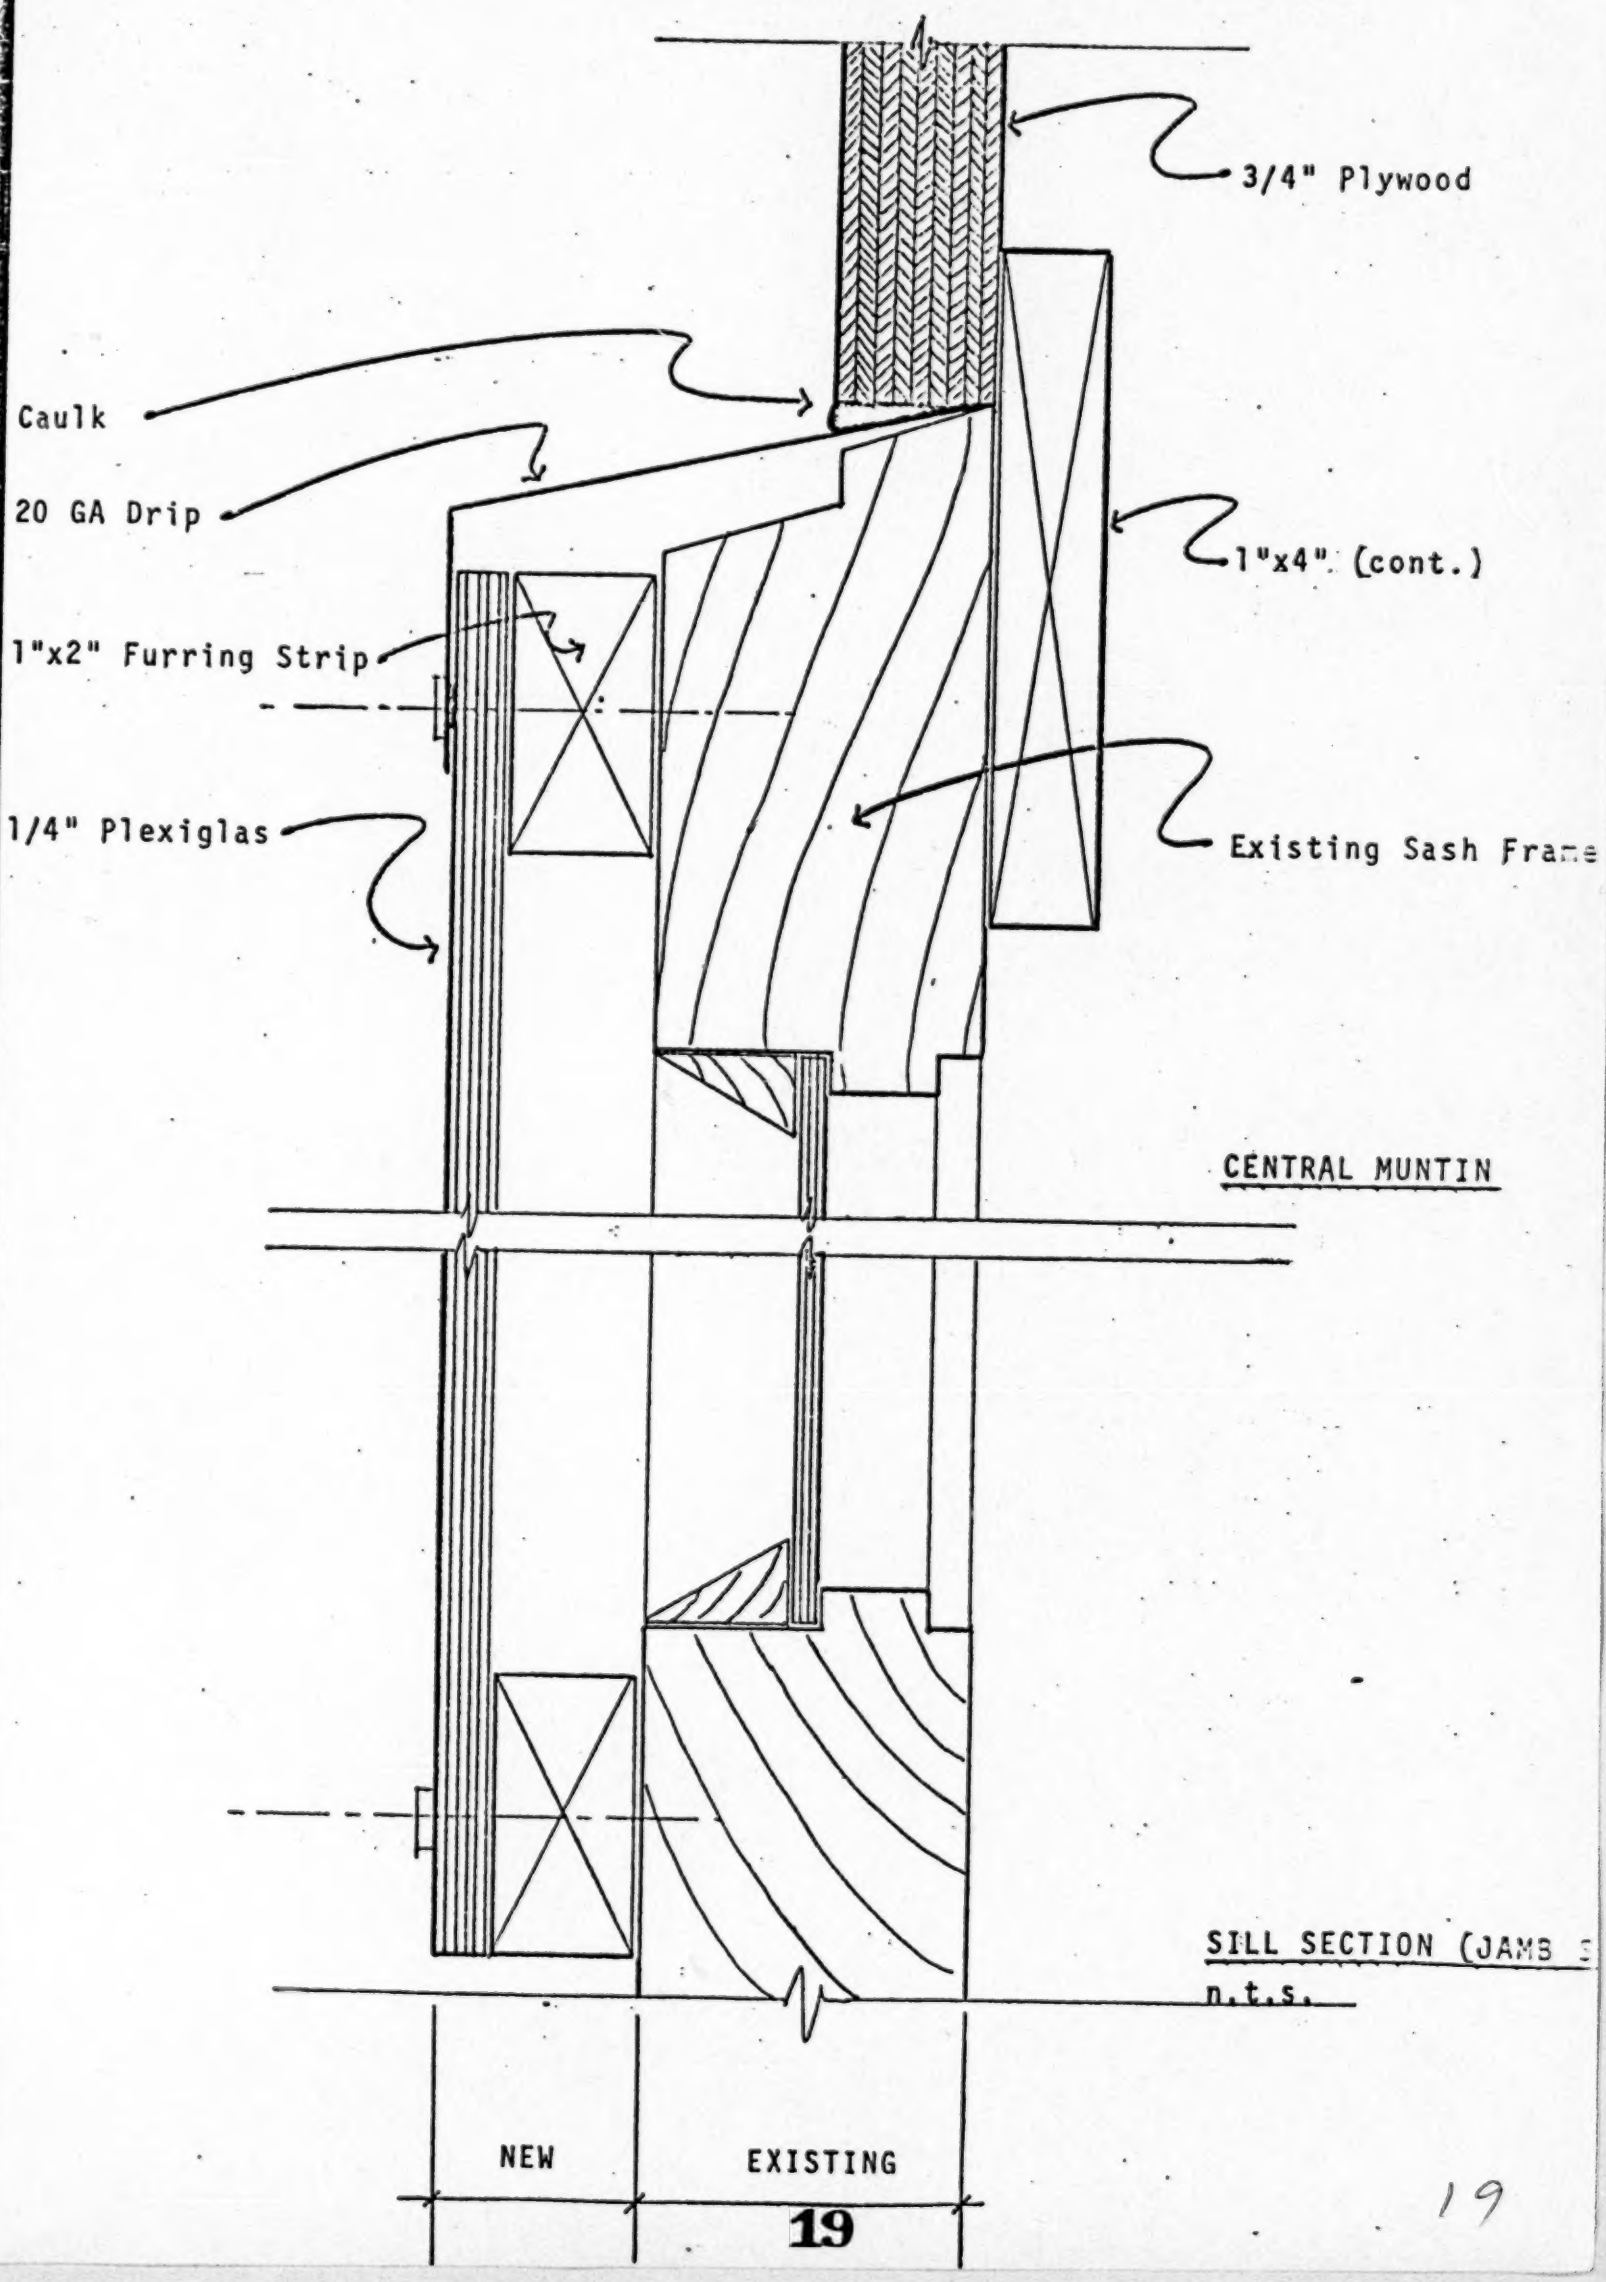
FIGURE 9: SKETCH DETAIL OF DOUBLE GLAZED WINDOWS

From the Survey it was found that the primary acoustical deficiency common to the majority of spaces was the lack of acoustical isolation provided by the windows. This inadequate isolation is due to several factors. The windows are the old type of wood frame, operable sash windows which have warped considerably over the past 40 years. Gaps between the sash and the sill can be

as much as 1/4" when the windows are completely closed and locked. Another important factor is that the type and patterns of vehicular traffic have changed significantly since these schools were built with a resulting increase in vehicular noise levels. Lastly, and most importantly, the school curriculum at the turn of the century when these schools were designed called for a common recess time for the entire school. Today classes rotate their recess times with the result that several classes use the playground continuously throughout the school day creating a day-long, high-level noise source.

In these schools the only available action for reducing the levels of disruptive exterior noise is to close the windows. Therefore our most important recommendation for remedial work was to improve the noise reduction provided by the windows. There were two degrees for this corrective work. The first was to eliminate the leakage paths and to provide airtight seals at the jamb and sill by means of resilient gasketing. The second, where higher exterior noise levels existed, such as from a playground, entailed permanently sealing the existing windows and applying a sheet of 1/4" Plexiglas to the exterior wood frame. Figure 9 shows the detail used for this corrective work.

We were fortunate to have the opportunity of evaluating the improvement in noise reduction provided by this construction in one of the schools used in the Survey. This slide [Figure 10] is a photograph of the exterior of a typical classroom adjacent to a playground. The next slide [Figure 11] shows a close-up of one of the windows. Next is a slide [Figure 12] showing the double glazing construction in place. The cost of this installation was approximately $2.00 to $2.50 per square foot including labor and materials.
